High Temperature Solar Receiver
Final Report
for the period
7 June 1979 - 7 April 1981

(NASA-CR-164332) HIGH TEMPERATURE SOLAR
RECEIVER Final Report, 7 Jun. 1979 - 7 Apr.
1981 (Sanders Associates, Inc.) 37 p
HC A03/MF A01

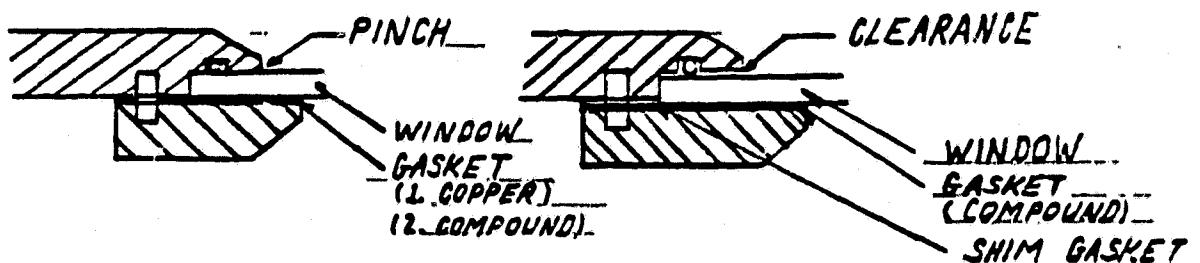
A number of windows have broken during the test sequence. Inspection of the failed parts and mounting flanges indicate the window failures were caused by interferences and stress concentrations related to flange design or tracking errors.

5. 8 Dec 80. Ran successful 50% solar test. The clean window performed very well and did not cloud up or get dirty during the test.
6. 10 Dec 80. Attempted 100% solar test. Window survived for 4 minutes and 30 seconds. Crack then propogated from 2 to 9 o'clock. Numerous small and incomplete cracks developed in upper fragment of window. Window did not burst. Slewed off sun and discontinued test. Inspection showed the window retainer flange had "coned" inward and forced window down against the lip of the window support flange. Increased deformation caused the window to

fracture. On 11 Dec 80 the window retention scheme was modified to allow additional clearance for the window retainer flange to distort. The retainer flange was shimmed .032" by use of a double gasket. The window is held off the support flange lip by an uncompressed c-ring.

The progression of window retention configurations tested during Nov-Dec 80 are shown below.
